ELIMINATING MP-2 NOISE GATE CHATTER

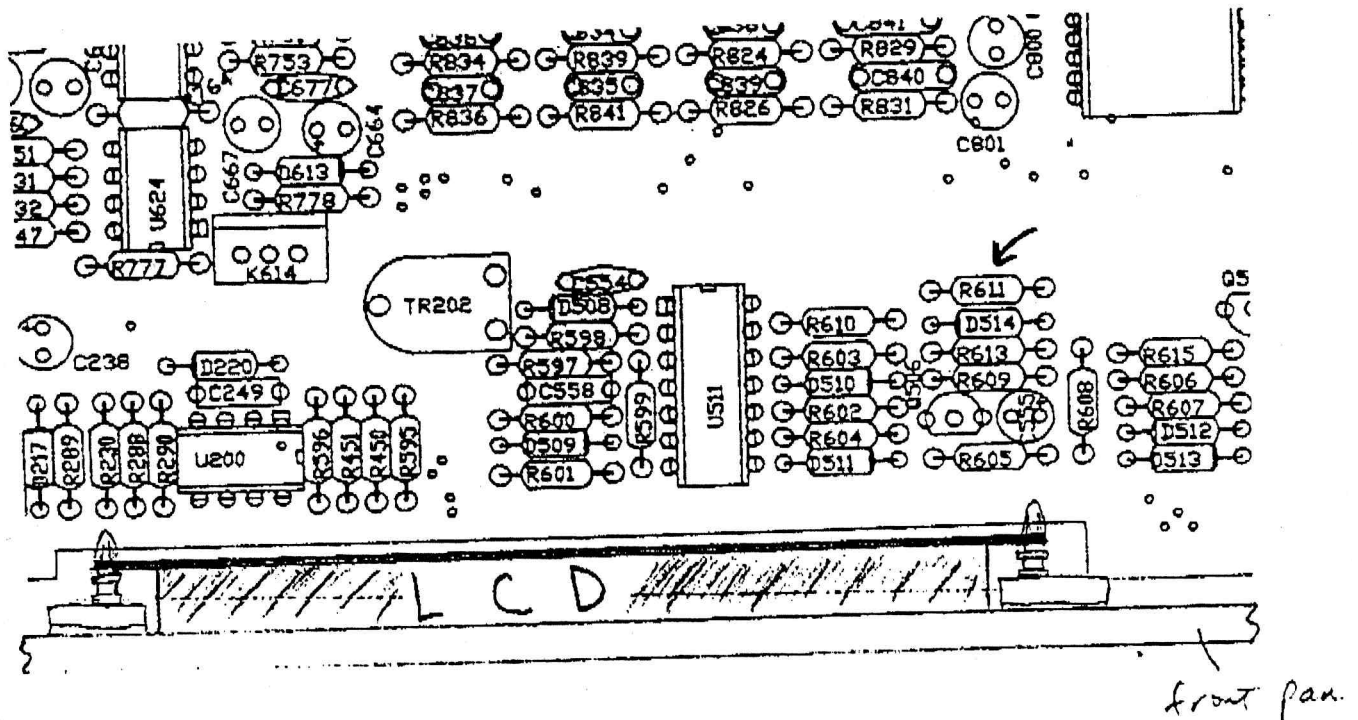
The MP-2 noise gate sometimes chatters on decaying legato notes.

Carefully remove the top and bottom lids from the MP-2 chassis. Behind the right edge of the LCD display, about an inch from the front edge of the circuit board, there is a 10Megohm resistor, R611 (10Megohm is indicated by brown, black, blue and gold bands, in that order). Replace this with a 3Megohm resistor (orange, black, green, and gold bands, in that order).

Although this is a very simple process, make sure you have some one with soldering experience perform this procedure. Also be very careful to not strip any of the tapped holes when you screw the lids back on.
